Commerical Inspection

951 Saraland Blvd S
Saraland, 36571

Commerical Example.inspx

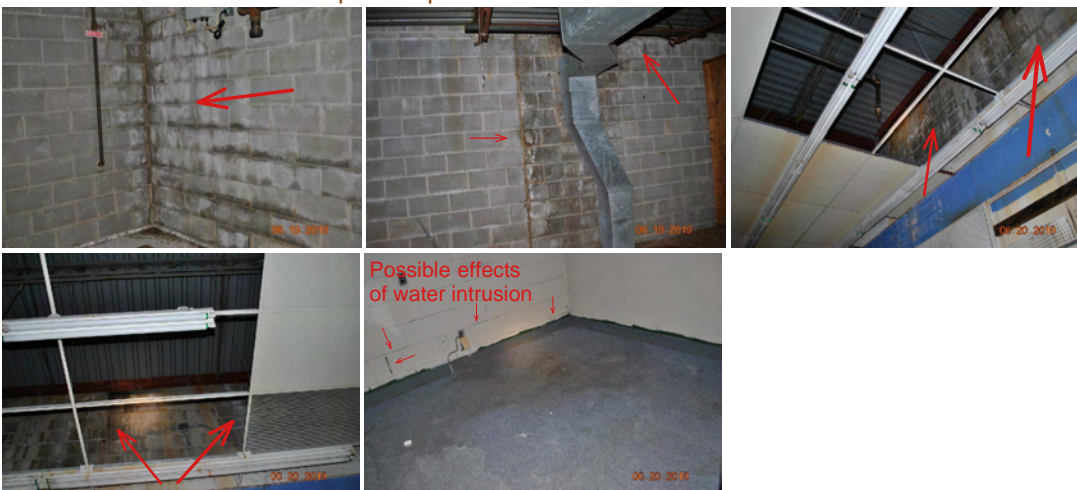
5. Efflorescence Concrete Block appears to be holding moisture - Efflorescence is a crystalline deposit of salts that can form when water is present in or on concrete block building surfaces. It has a white or greyish tint and consists of salt deposits left behind when water evaporates. In addition, efflorescence can appear as a powdery substance on floors and walls and requires special care to treat.

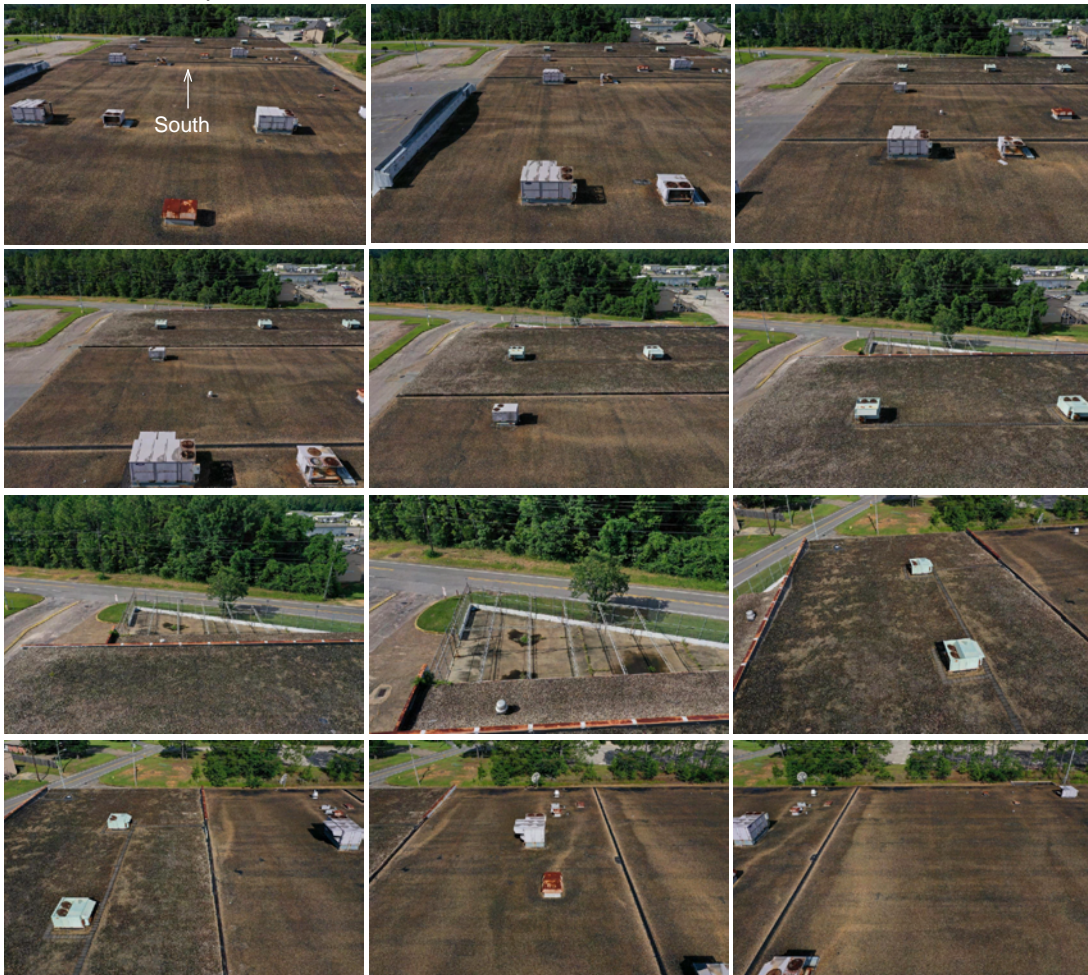
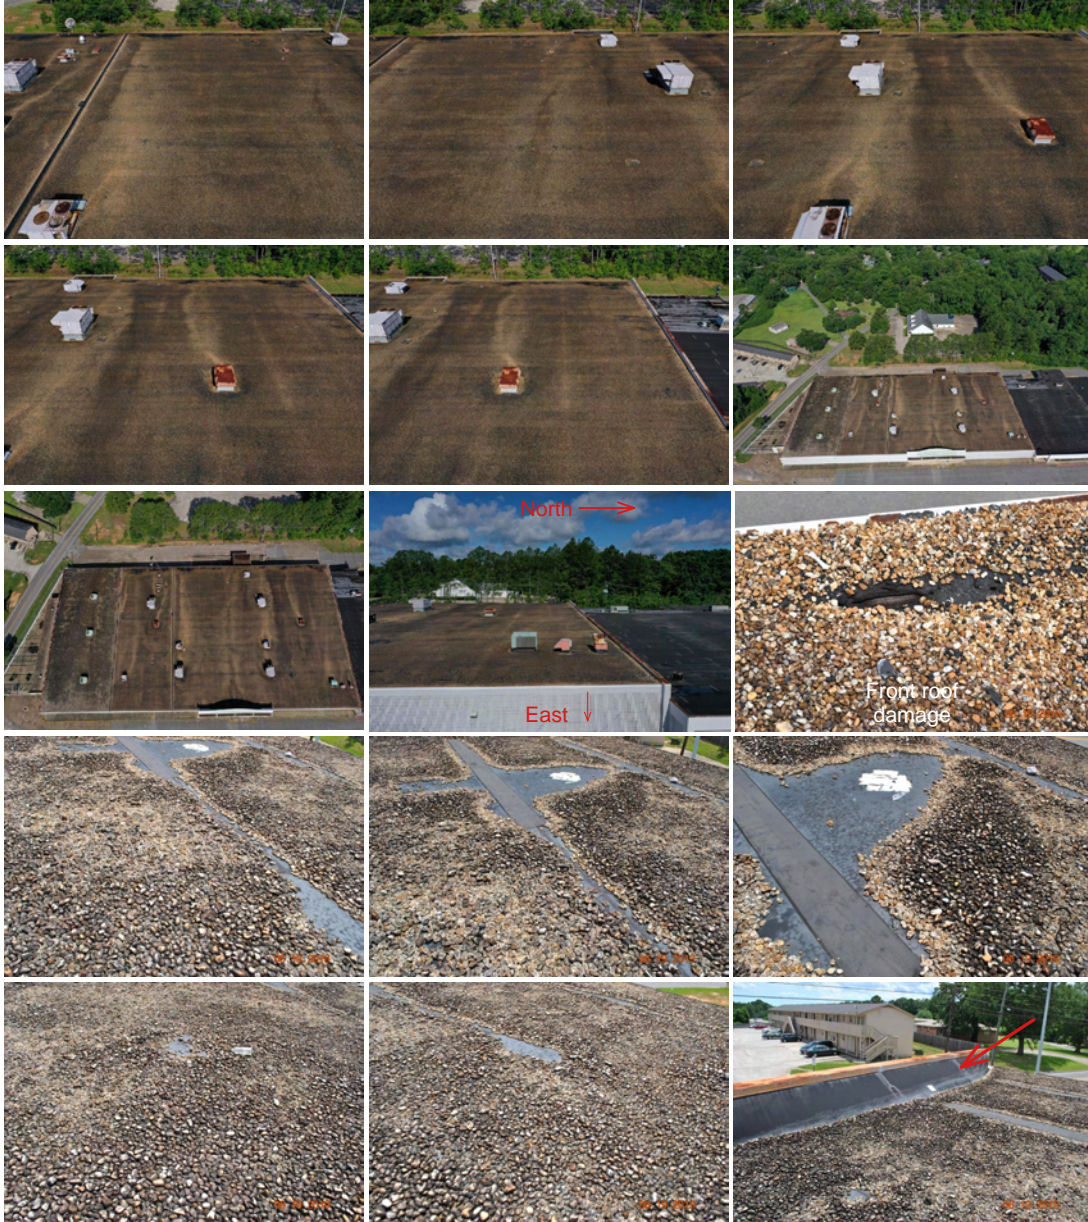
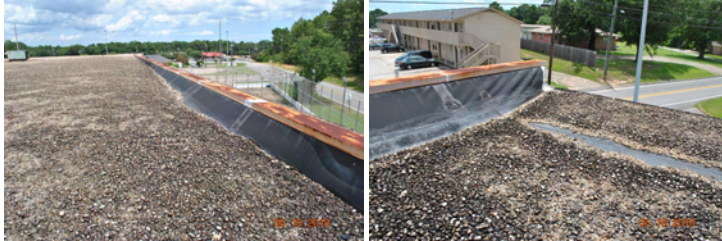
During inspection of roof southwest corner of roof has confirmed interior damages. underlayment appears to be separating from end wall cap, It is possible that aggregate pebbles are to large and weight has caused stress On underlayment . Roofing license contractor is recommended for best fixes for total roofing

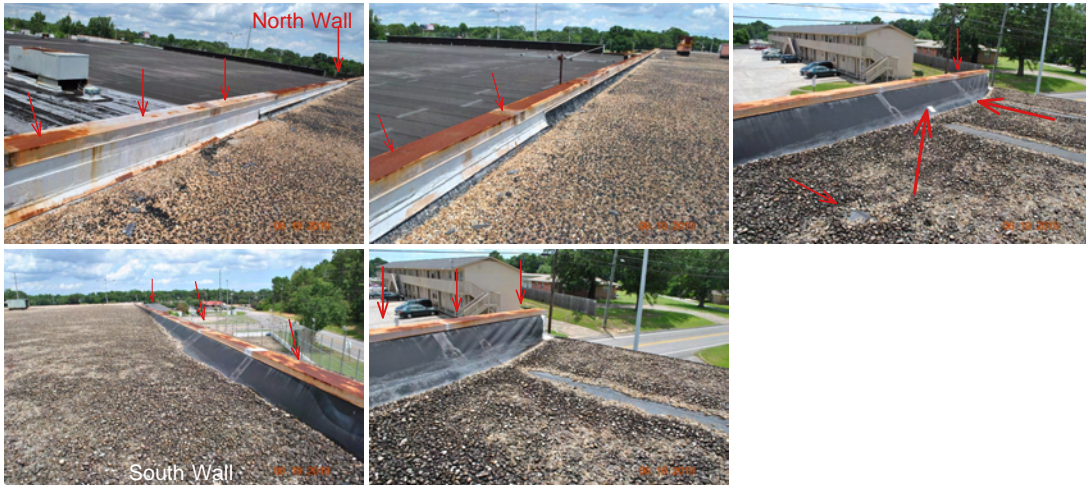
6. Flashing: Metal - It appears that inspection of roof found several areas of concern to metal wall caps and raised roof connections. it appears that south west roofing is still a area of concern for leaking, Evaluation by a license roofing contractor is recommended.

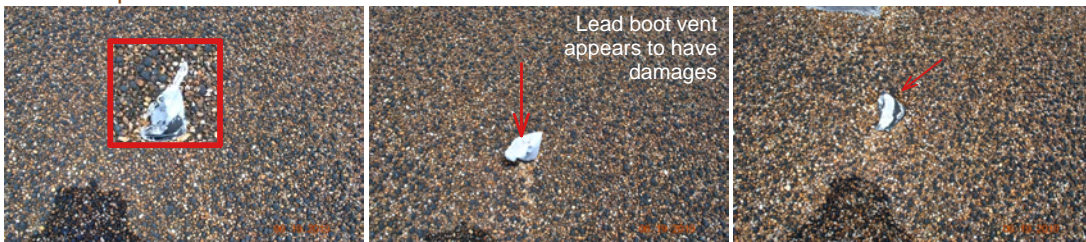
9. Plumbing Vents: PVC - For some reason it appears that vent pipes have been crashed, A licensed roofer & plumber is recommended.

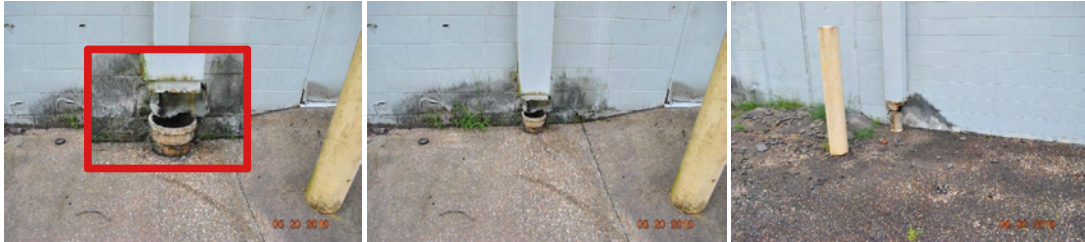
13. Gutters: Metal
14. Downspouts: Metal - Downspout ground reducer located various places are damaged to the point that replacement is necessary. Evaluation by maintenance or contractor is recommended.

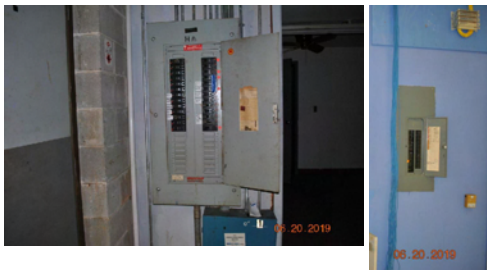
4. Ground: Plumbing and rod in ground
5. Sub Panels: Main floors and second floor - Evaluation by a licensed electrician is recommended

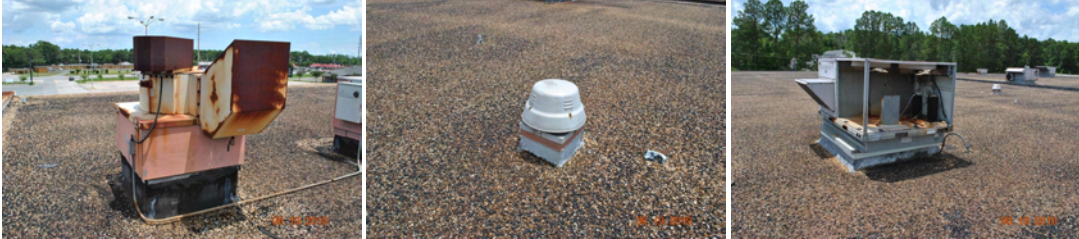
1. HVAC Operation: Inoperative at time of inspection - Power was disconnected at main service.
2. Other Observations: Heating & Cooling systems appear to have been compromised, only a selective about of photos are added, which will represent possible vandalism to all or most rooftop systems including ventilation systems. replacement may be needed for all systems effected. Evaluation by a licensed HVAC and electrical contractors is recommended,

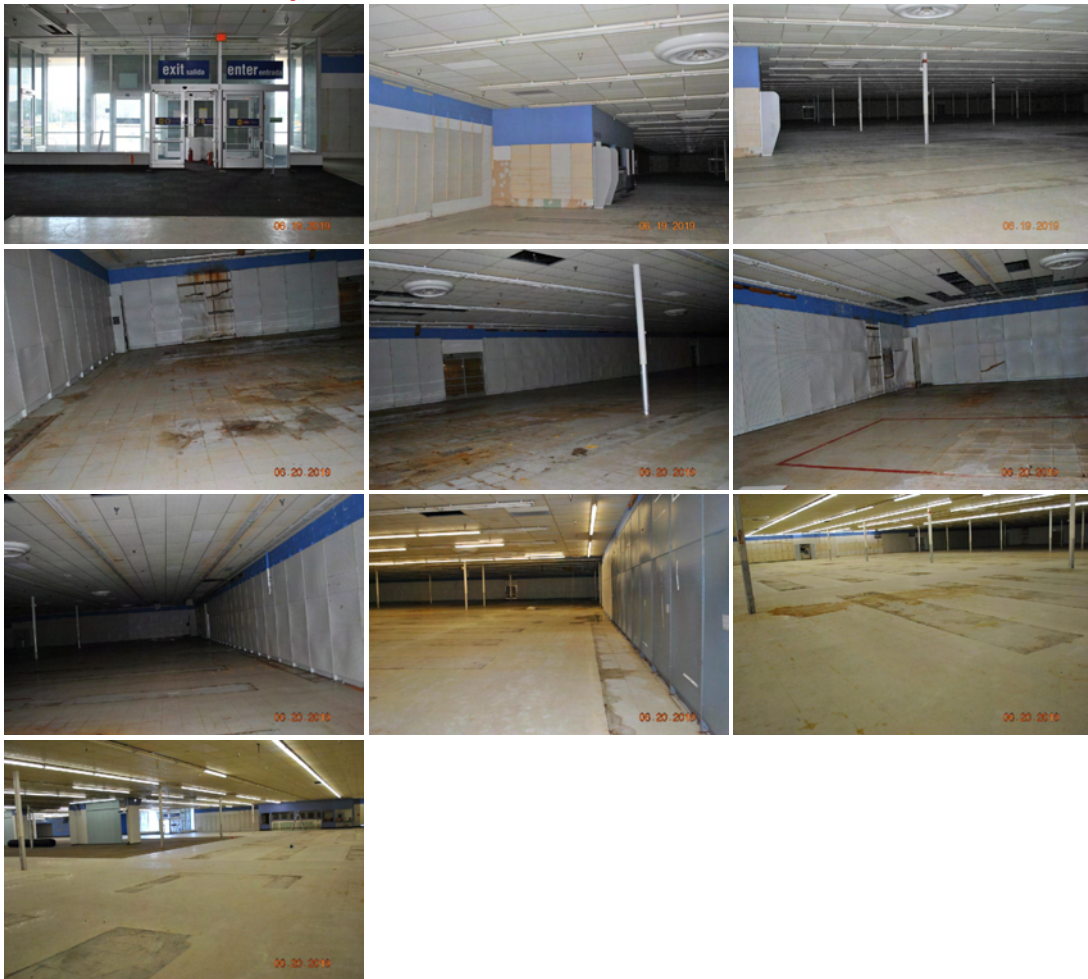
1. Walls: Wood panel board - Noted moisture damages to walls caused by exterior walls, roof, pipe leaks, or ac condensation or without climate control. it appears remediation process should be considered. Evaluate by a licensed contractor is recommended.

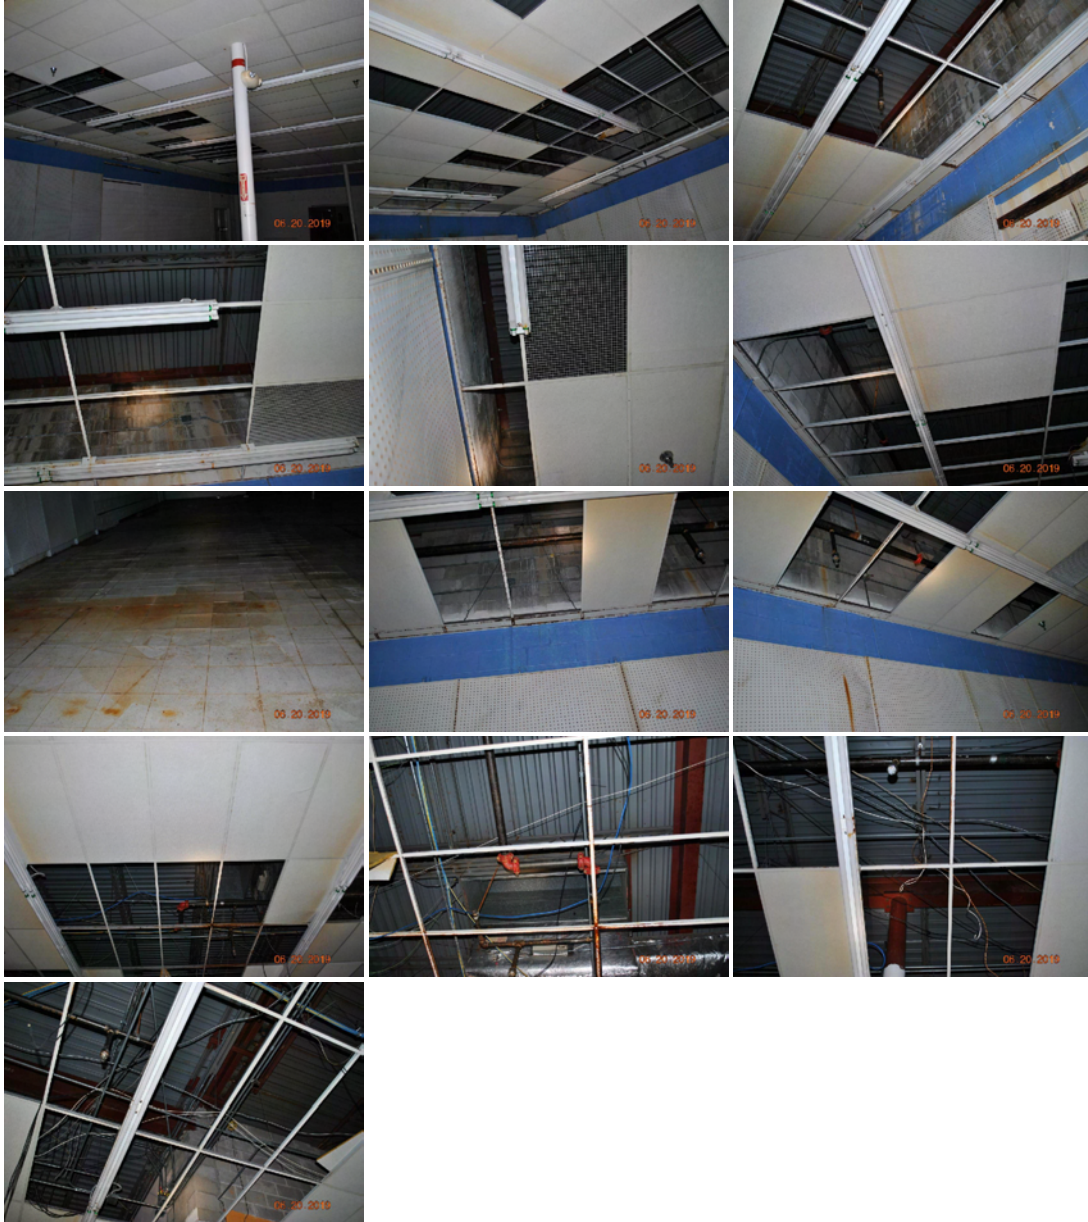
2. Ceiling: Ceiling Tiles - Noted moisture damages to ceiling tiles caused by exterior walls, roof, pipe leaks, or ac condensation or without climate control. it appears remediation process should be considered. Evaluate by a licensed contractor is recommended.

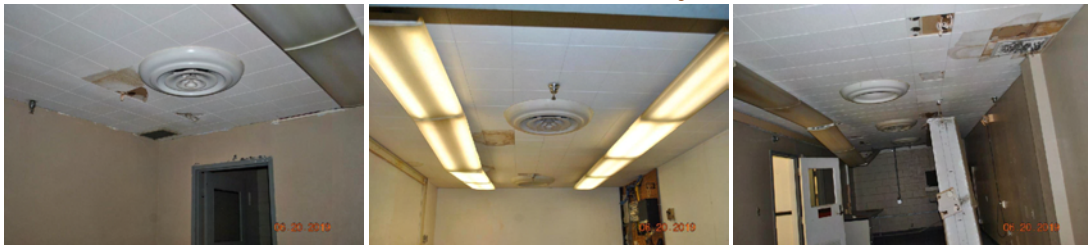
2. Ceiling: Drywall & Paint - Sagging ceiling tiles is caused by exterior walls, roof, pipe leaks, or ac condensation or without climate control. Evaluation by a contractor is recommended

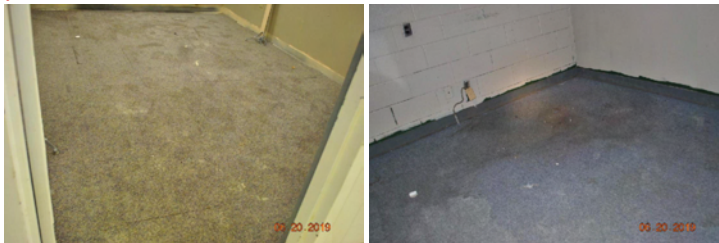
4. Floor: Vinyl floor covering/peel & stick, Carpet - Floor shows evidence of previous water penetration/stains

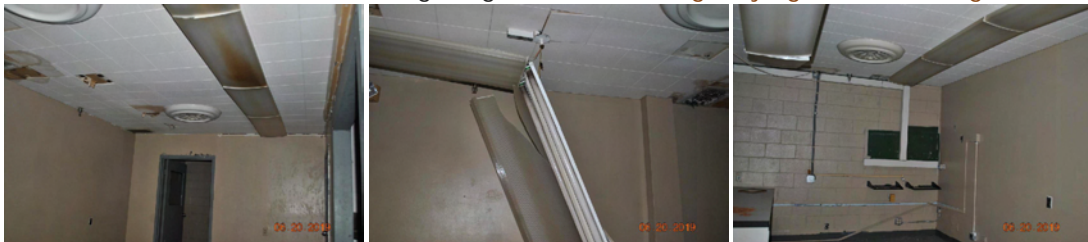
6. Electrical: 120 VAC outlets and lighting circuits - Emergency light not working as intended

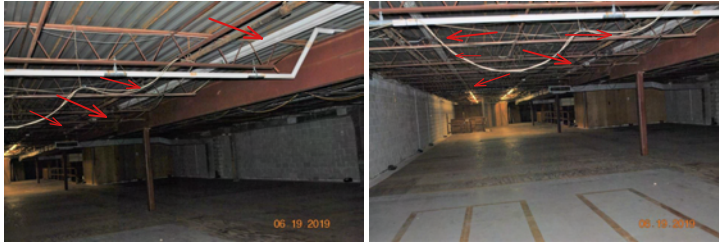
6. Electrical: 120 VAC outlets and lighting circuits - **Light fixture not functional-repair/replace, Evaluation by a licensed electrician is recommended**

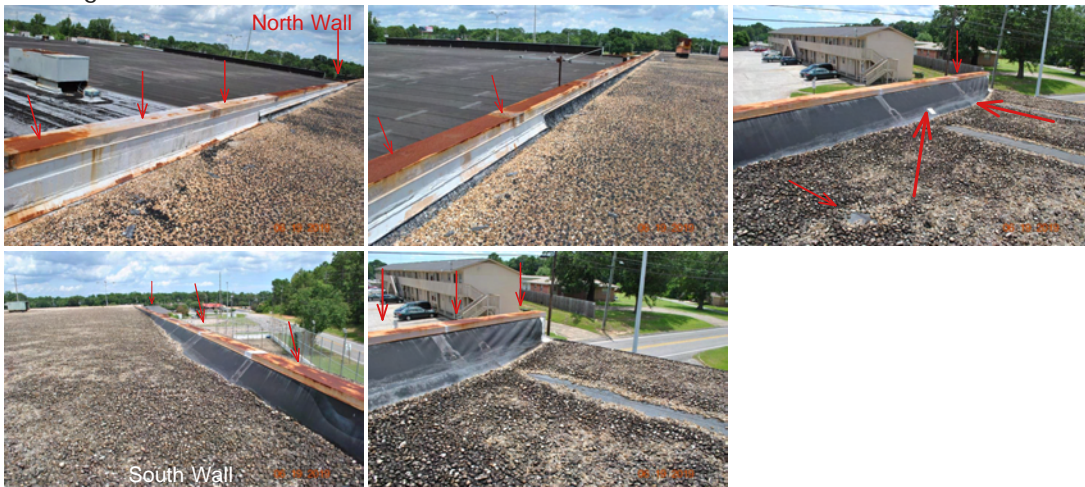
9. Flashing: Metal - It appears that inspection of roof found several areas of concern to metal wall caps and raised roof connections. It appears that south west roofing is still a area of concern for leaking, Evaluation by a license roofing contractor is recommended.

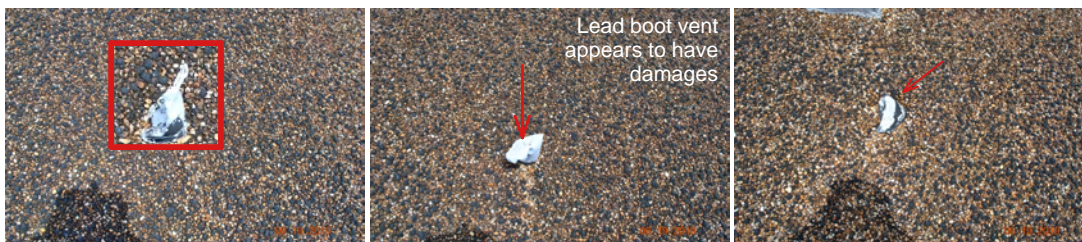
10. Plumbing Vents: PVC - For some reason it appears that vent pipes have been crashed, A licensed roofer & plumber is recommended.

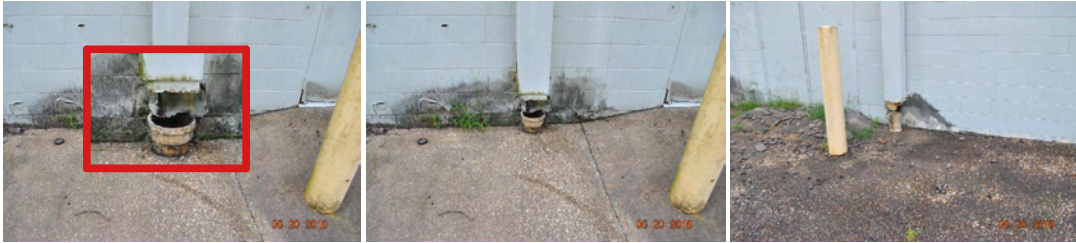
11. Downspouts: Metal - Downspout ground reducer located various places are damaged to the point that replacement is necessary. Evaluation by maintenance or contractor is recommended.

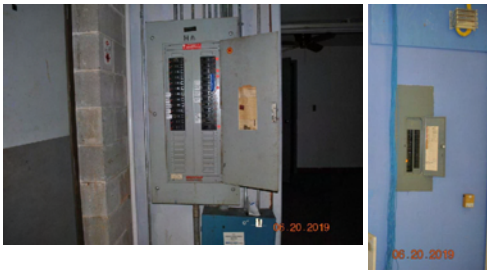
13. Service: Outside Main Transformer Underground
14. Main Disconnects: Face lever
15. Sub Panels: Main floors and second floor - Evaluation by a licensed electrician is recommended

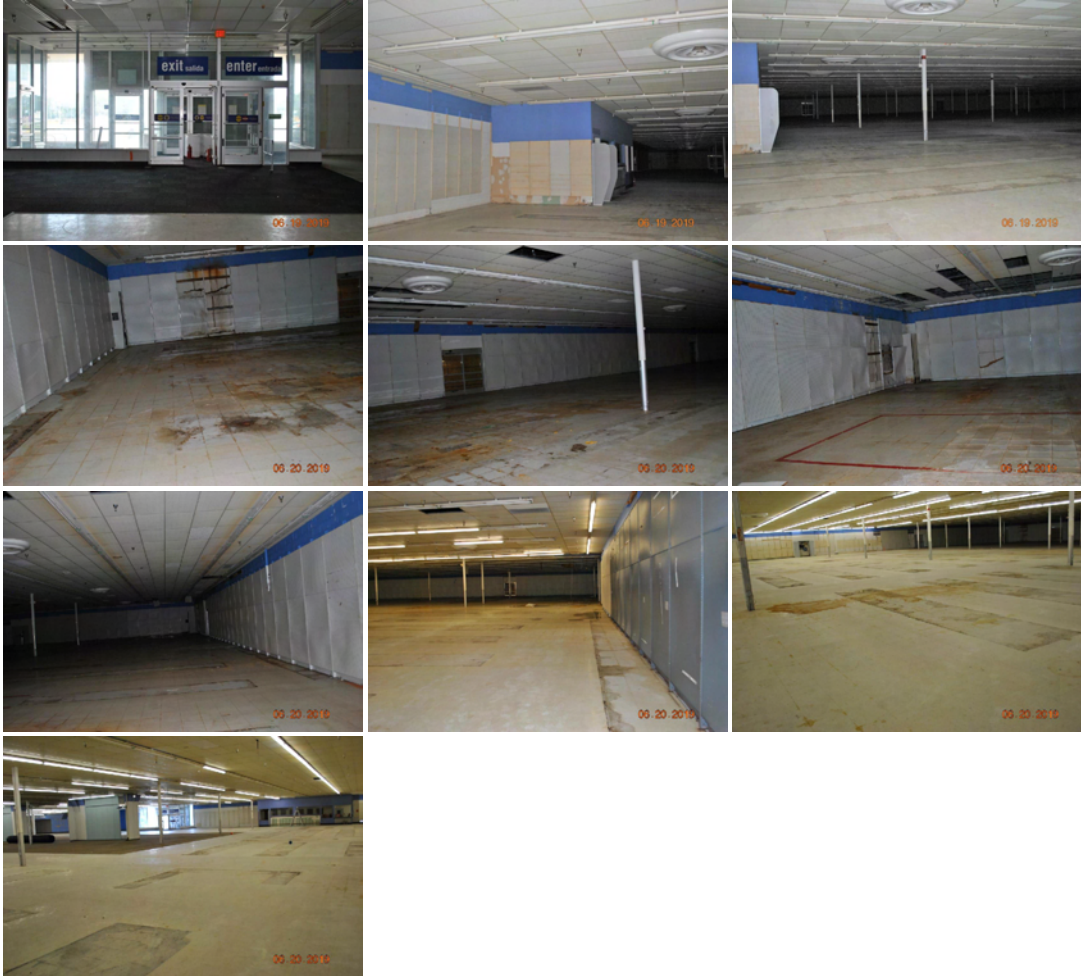
22. Walls: Wood panel board - Noted moisture damages to walls caused by exterior walls, roof, pipe leaks, or ac condensation or without climate control. it appears remediation process should be considered. Evaluate by a licensed contractor is recommended.

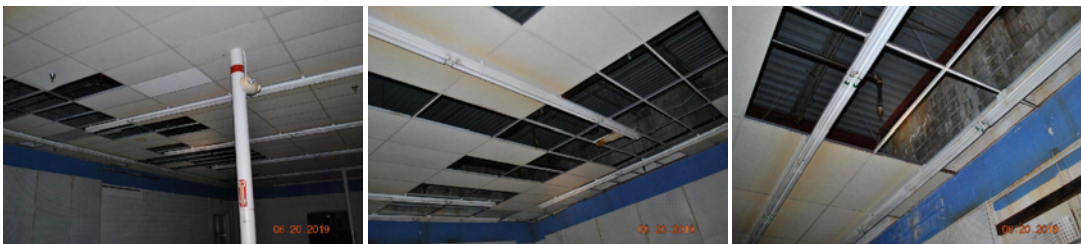
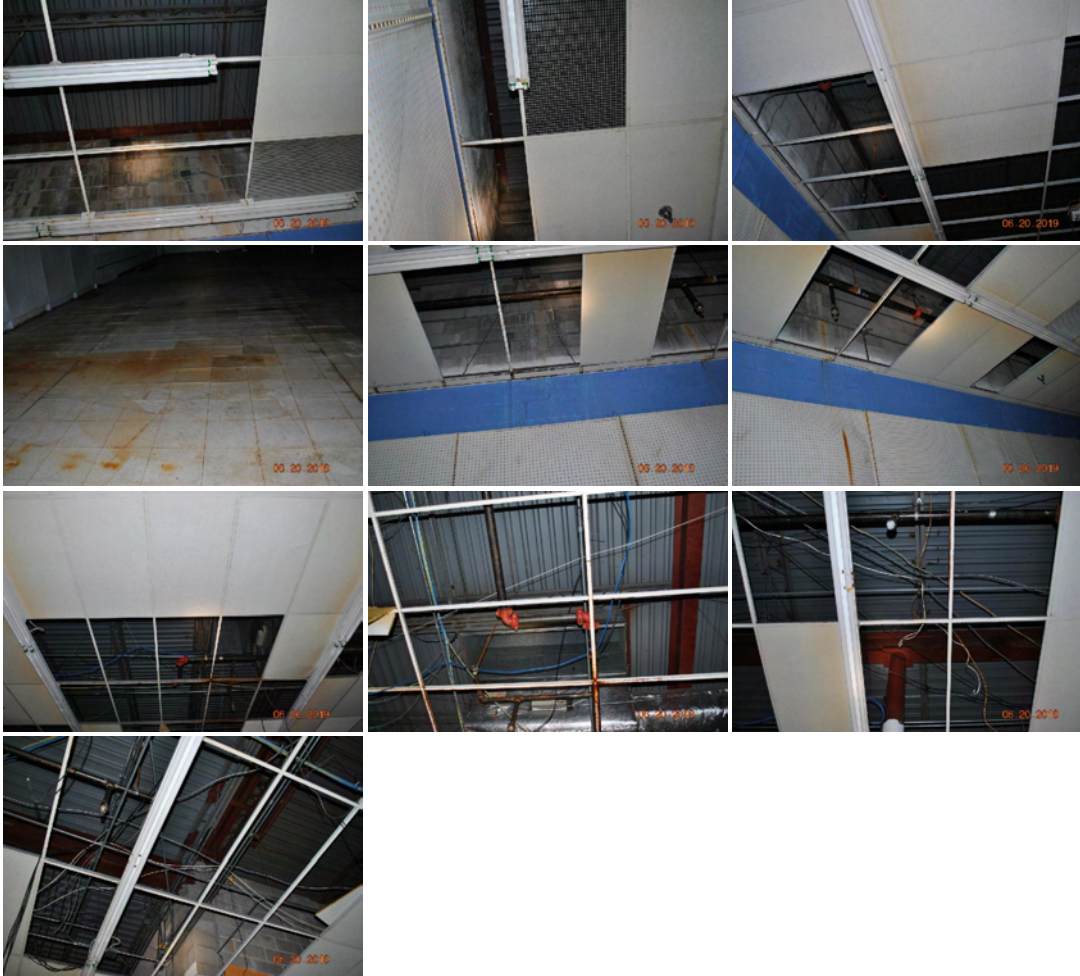
23. Ceiling: Ceiling Tiles - Noted moisture damages to ceiling tiles caused by exterior walls, roof, pipe leaks, or ac condensation or without climate control. it appears remediation process should be considered. Evaluate by a licensed contractor is recommended.

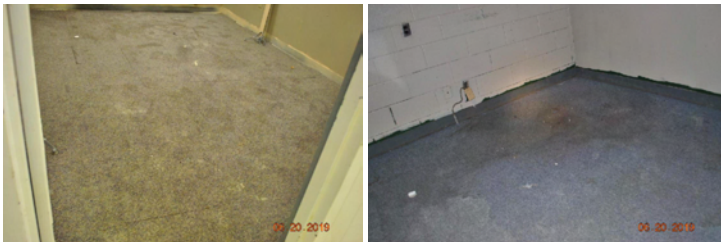
55. Front Office Office Space Floor: Vinyl floor covering/peel & stick, Carpet - Floor shows evidence of previous water penetration/stains

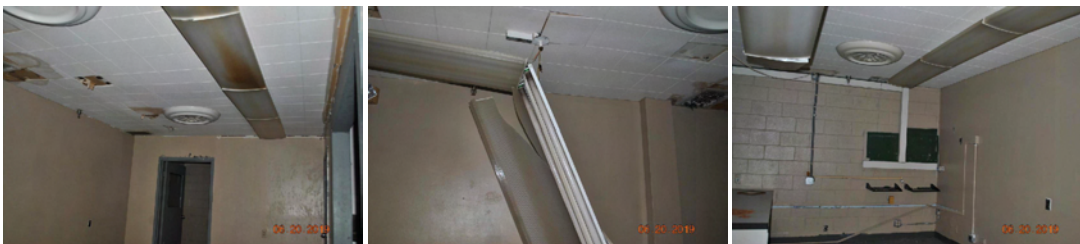
56. Front Office Office Space Electrical: 120 VAC outlets and lighting circuits - Emergency light not working as intended

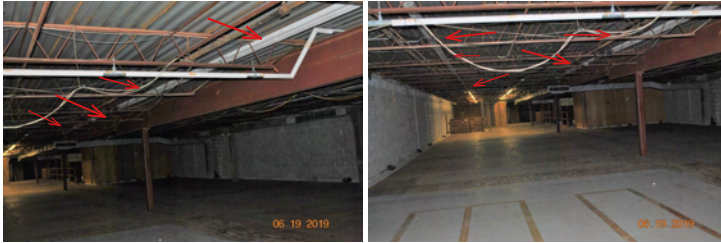
60. Interior Work Area Electrical: 120 VAC outlets and lighting circuits - Light fixture not functional-repair/replace, Evaluation by a licensed electrician is recommended
