Commerical Inspection

951 Saraland Blvd S
Saraland, 36571

Commerical Example.inspx

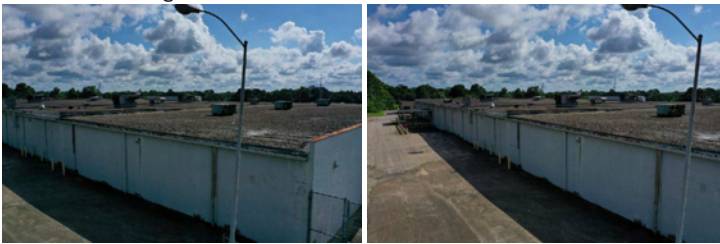
3. Wall Covering: Concrete hollow-core blocks

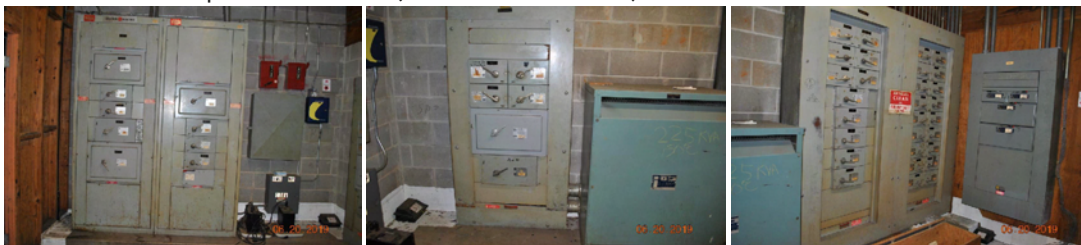
1. Service: Outside Main Transformer Underground
2. Main Disconnects: Face lever
3. Service Size Amps: 900- 1200 (Needs Verification)

4. Ground: Plumbing and rod in ground
5. Sub Panels: Main floors and second floor - Evaluation by a licensed electrician is recommended

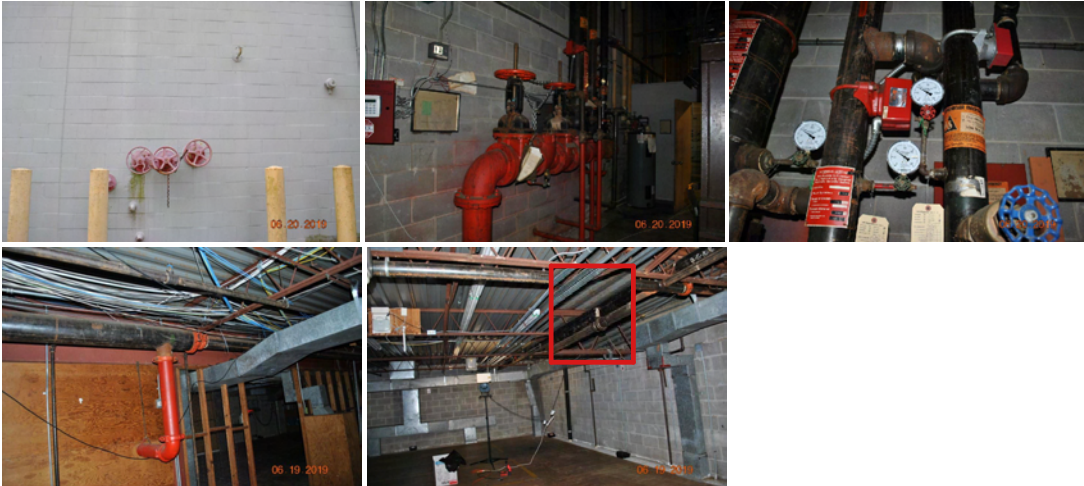
1. Main Service Line: 3"Black Steel Pipe

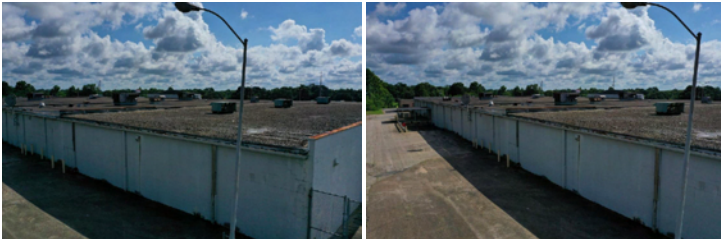
2. Right Elevation Exterior Surface Wall Covering: Concrete hollow-core blocks
3. Rear Elevation Exterior Surface Wall Covering: Concrete hollow-core blocks

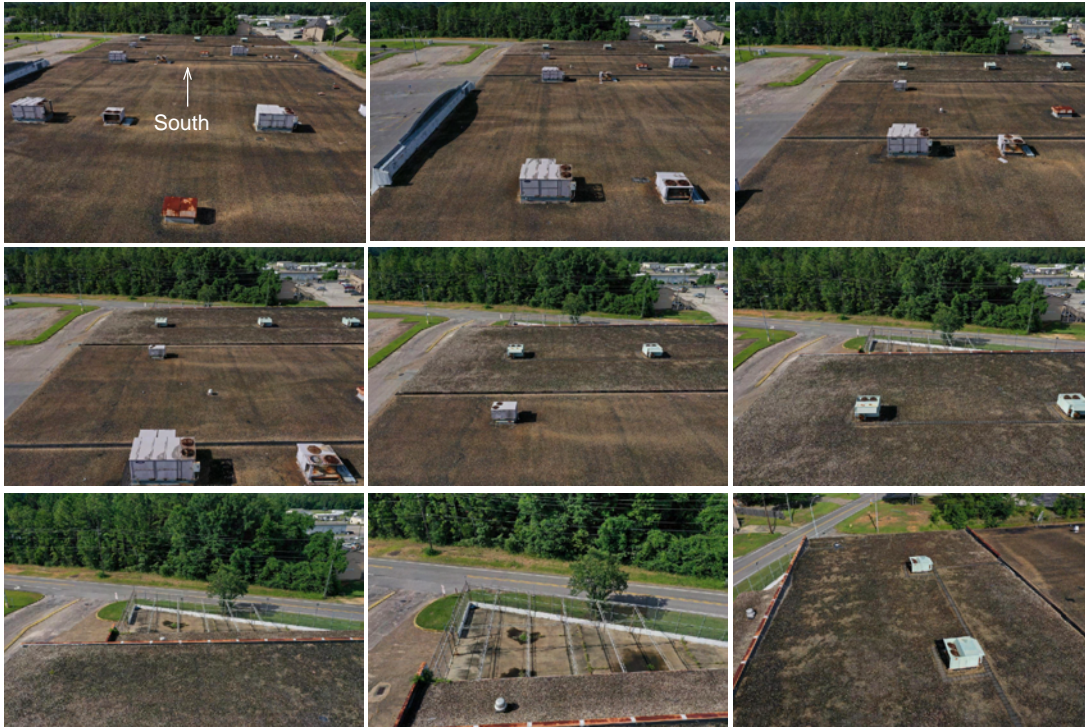
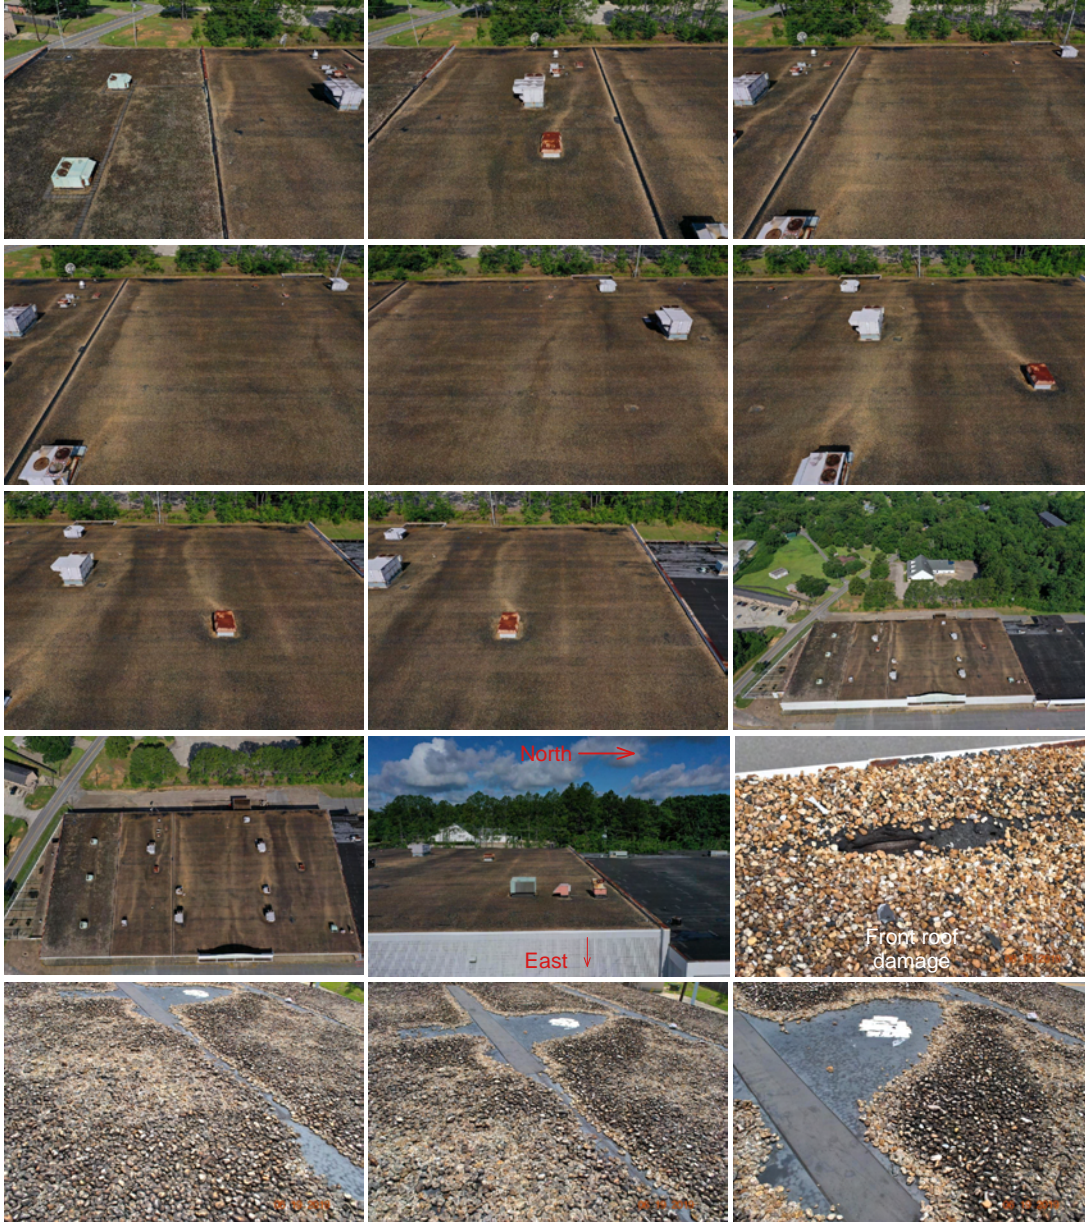
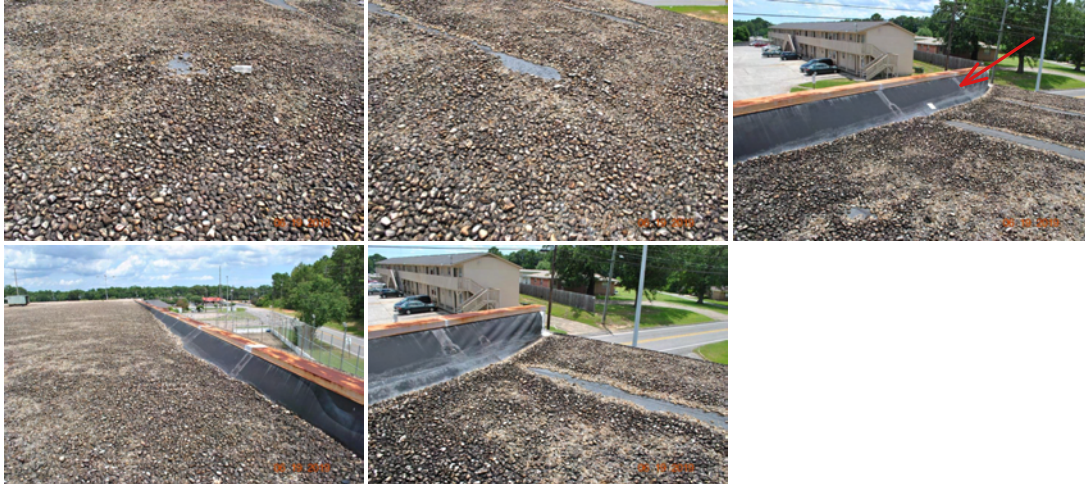
8. All Slopes Roof Surface Material: Built-up with Rocks

9. Flashing: Metal - It appears that inspection of roof found several areas of concern to metal wall caps and raised roof connections. It appears that south west roofing is still a area of concern for leaking, Evaluation by a license roofing contractor is recommended.

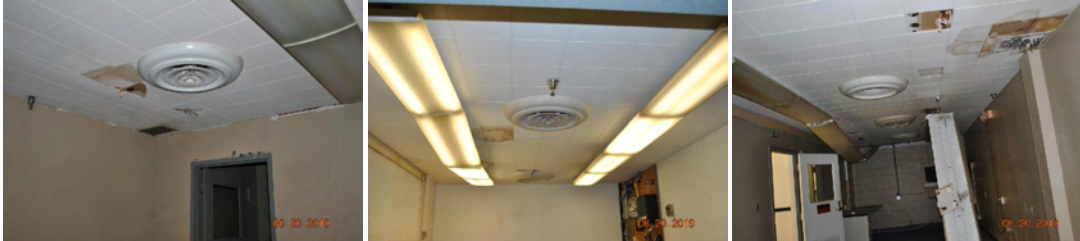
55. Front Office Office Space Floor: Vinyl floor covering/peel & stick, Carpet - Floor shows evidence of previous water penetration/stains
